**Flood Control Project Maintenance
Levee Inspections**

Fall 2010 Levee Maintenance Deficiency Summary Report

Waterway			Bank	Unit Miles
Unit No. 01 Right Bank Cache Creek			Right	0.29
	Spring (March - May)	Summer (June - August)	(September - November) Fall	Winter (December - February)
Unit Maintenance Rating (Fall Only)			U	
Date of Inspection	3/16/2010		10/12/2010	
DWR Inspector	John Williamson		John Williamson	
Accompanied By

Levee Inspection Report By Mile - Fall 2010

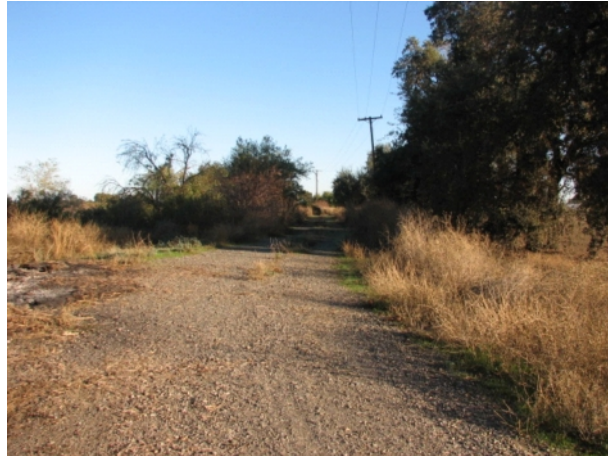
Levee Mile Report Line	1
Start Levee Mile	0.00
End Levee Mile	0.26
Location	Land Side
Category	Earthen Levee
Item	Vegetation
Unmowed vegetation on landside and waterside.	
johngw_f_20101108_290.jpg

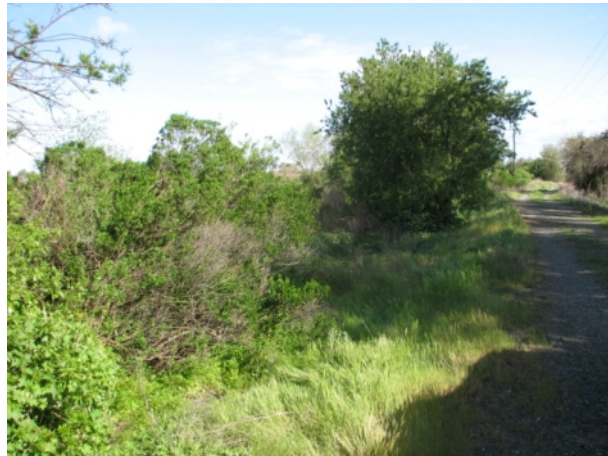
Levee Mile Report Line	2
Start Levee Mile	0.01
End Levee Mile	0.26
Location	Water Side
Category	Earthen Levee
Item	Vegetation
brush on water side	
johngw_f_20101012_074.jpg

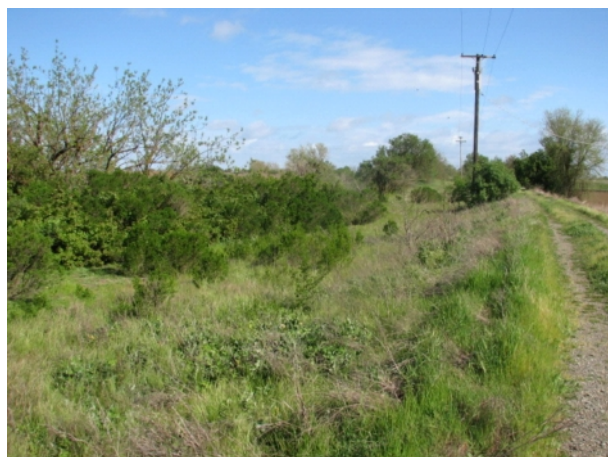
Levee Mile Report Line	2
Start Levee Mile	0.01
End Levee Mile	0.26
Location	Water Side
Category	Earthen Levee
Item	Vegetation
brush on water side	
johngw_f_20101012_075.jpg

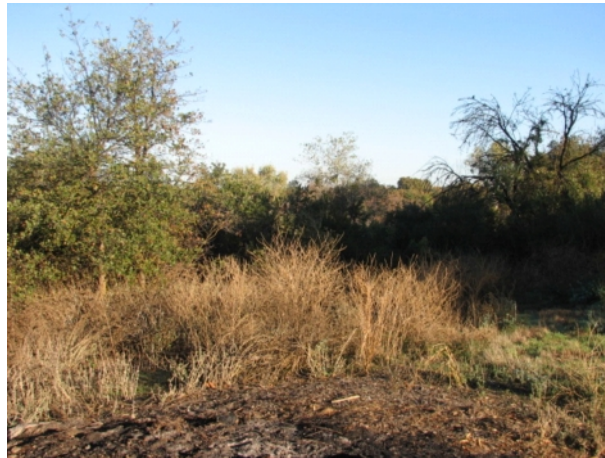
Levee Mile Report Line	5
Start Levee Mile	0.03
End Levee Mile	0.06
Location	Water Side
Category	Earthen Levee
Item	Trim / Thin Trees

Unwanted brush on the waterside berm.

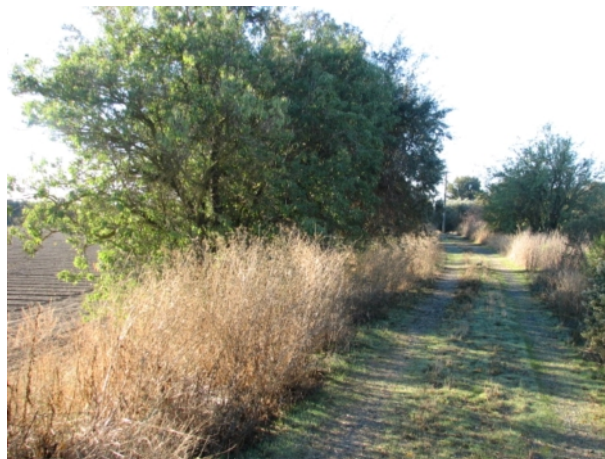
Levee Mile Report Line	6
Start Levee Mile	0.08
End Levee Mile	0.08
Location	Land Side
Category	Earthen Levee
Item	Trim / Thin Trees

Trees on the landside need to be raised to 5' for viewing of slope.

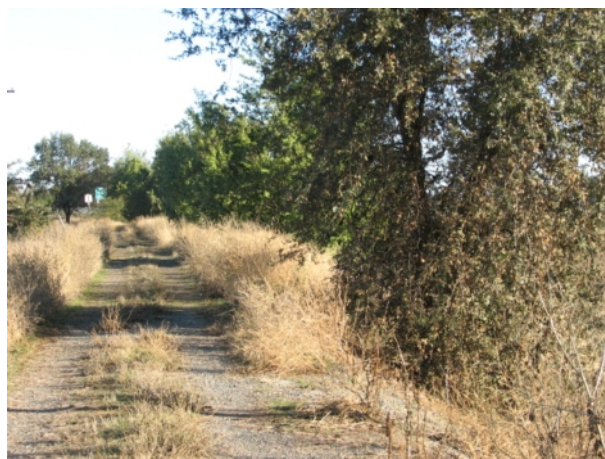
Levee Mile Report Line	8
Start Levee Mile	0.15
End Levee Mile	0.15
Location	Land Side
Category	Earthen Levee
Item	Trim / Thin Trees

All trees on the landside need to be raised. This view is looking downstream.
